NRL Report 8193

6 A Correlation Between SCC Path,  
Hardness, Microstructure, and Microsegregation  
in HY-130 E14018 Weld Metal,

10 F. W. FRASER, E. A. METZBOWER, J. STOOP

11 22 December 1978

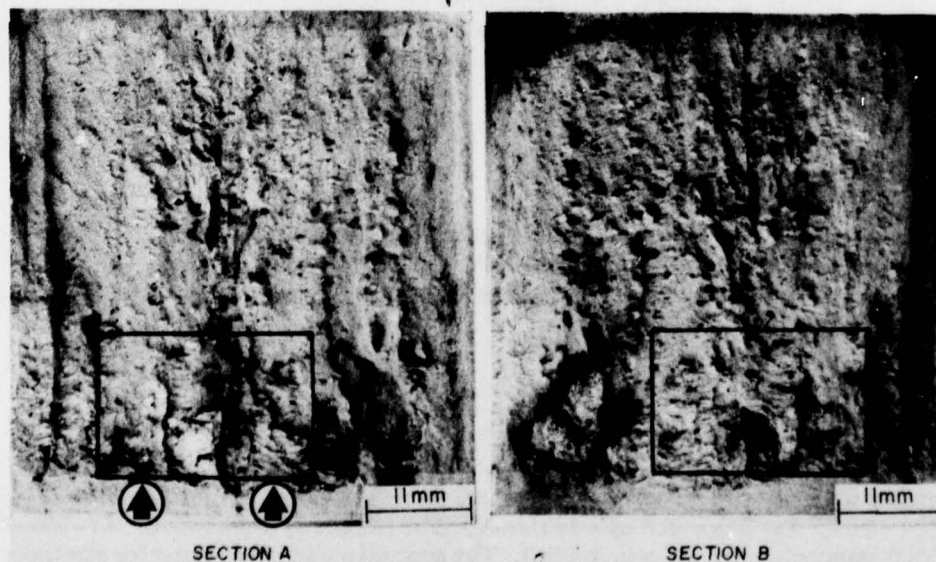
Fig. 1 — Mating halves of HY-130 weldment fractured during stress corrosion testing. Outlined areas indicate portions of specimen analyzed. The arrows indicate edge along which fractographic studies were carried out on section A.

The mating halves of a single edge-notch, cantilever-beam specimen, which had been fractured under stress in a corroding medium, were utilized in this investigation (Fig. 1). This specimen was fabricated as a double-V, SMA (E14018) weldment of HY-130 steel. Welding parameters are given in Table 1. The specimen had been tested for stress corrosion, electrochemically, while galvanically coupled to zinc [3].

The areas of sections A and B, outlined in Fig. 1, depict the analyzed portions of the specimen which encompassed the mid-thickness region, or root, of the weldment, thereby supplying a specimen comprised of weld metal, fusion zone, and heat-affected zone (HAZ).

Fractographic studies of section A, along the edge of stress corrosion cracking (SCC) initiation (arrows), were carried out with the aid of a scanning electron microscope (SEM).

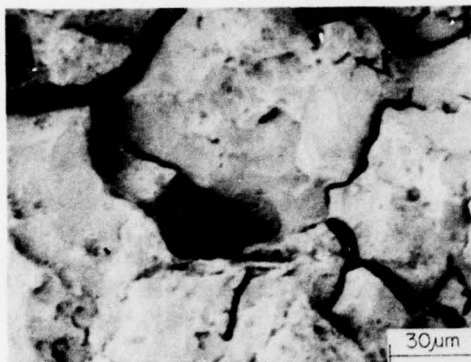
Fig. 5 — Intergranular fracture found in equiaxed grain area of weld bead 4

Macroscopic examination of the fracture surface at the center of specimen A showed numerous small facets of varying orientation. These facets corresponded, in location, to the equiaxed grains in bead 4, as seen in the polished cross section (Fig. 3). The fracture mode in this area was largely intergranular (Fig. 5).

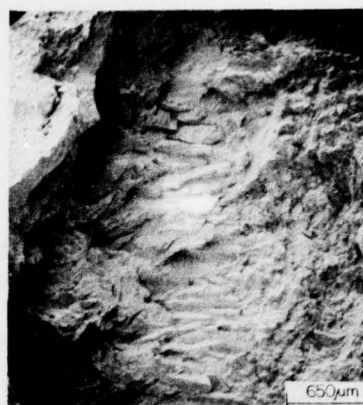
Fig. 6 — Columnar and adjacent refined grain areas showing predominantly transgranular fracture

Although intergranular fracture was observed to some extent in the columnar and adjacent refined grain areas of each weld bead, as illustrated by Figs. 6 and 7, the fracture mode, as seen in Fig. 6, was generally transgranular. Both cleavage and microvoid coalescence (MVC) were found in the areas of transgranular fracture.

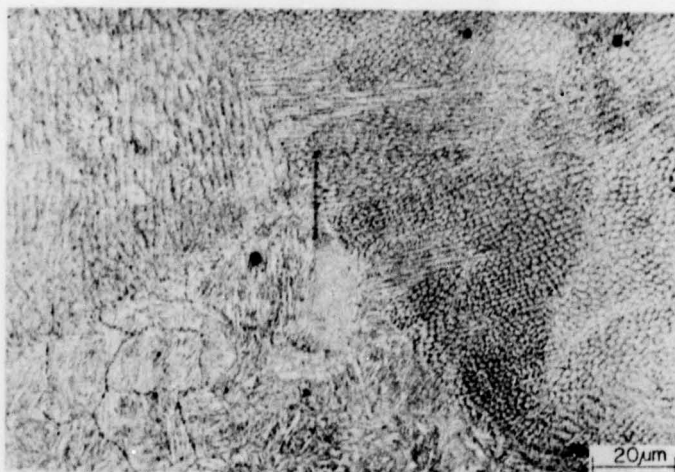
Fig. 21 — Fusion zone at the center of the weldment. Line indicates path of beam during microprobe analysis (etched with 10% ammonium persulfate solution).

As seen in Fig. 19, the fusion zone showed a dark etched band along the edge adjacent to the weld metal proper. However, at the center of the weldment, the fusion zone could not be readily identified optically (Fig. 21). Microprobe analysis of this area showed a more uniform compositional gradient (Fig. 22), suggesting more thorough mixing of the melted base metal and weld filler metal and the probable diffusion of the alloying elements due to the repeated thermal cycling at the root of the weldment.
